Manhole Inspection Summary

Manhole # S29AA2008MH

Location Address: **COTSWOLD RD** Cross Street: **CHARLES ST**

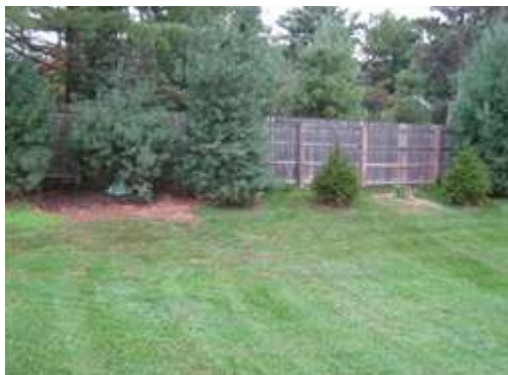
Location View

View of Location at soccer field

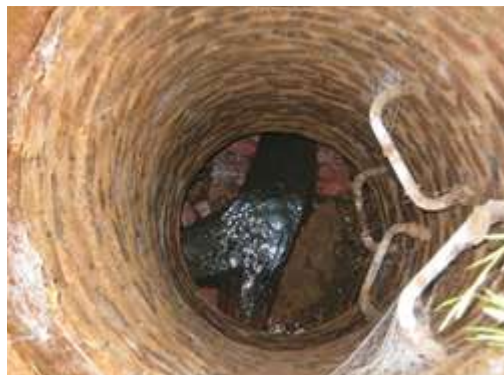
Top View

Adjustment, Corbel and Barrel infiltration. Corroded steps. Evidence of surcharge - Bench debris.

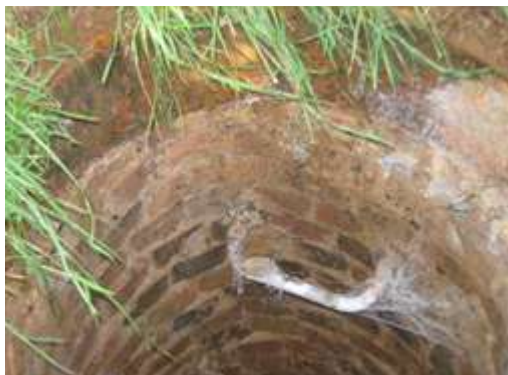
Defect

Adjustment infiltration.

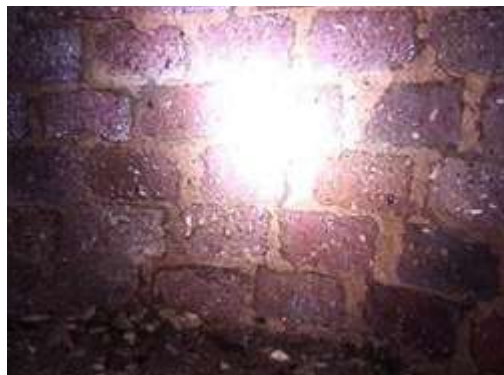
Defect

Barrel infiltration.

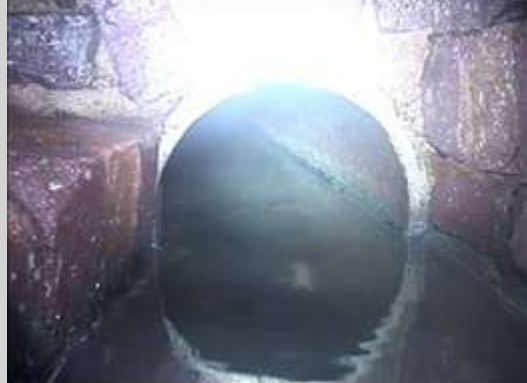
8 in. Circular Gravity Sewer Pipe Out @ 12 O'Clock

Pipe Material: **Clay** ☐ Pipe Lined

Invert Depth: **10.80** (ft.) Flow Characteristics: **Slow**

Infiltration: **None** Pipe Seal Cond: **Unknown**

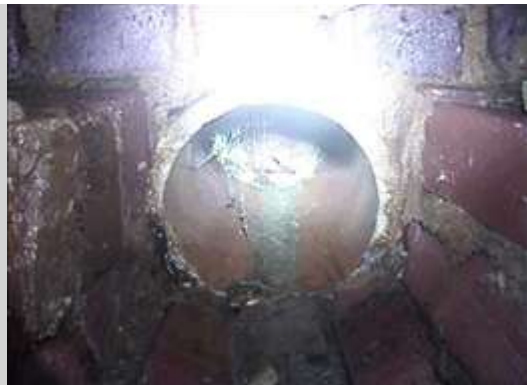
8 in. Circular Gravity Sewer Pipe In @ 6 O'Clock

Pipe Material: **Clay** ☐ Pipe Lined

Invert Depth: **10.42** (ft.) Flow Characteristics: **None**

Connects To: **Stub connection / abandoned**

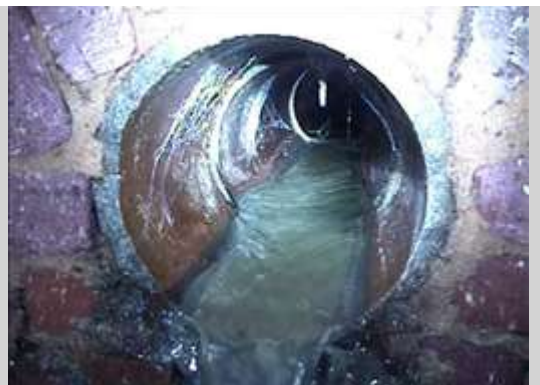
Pipe In @ 9 O'Clock

Pipe Material: **Clay**

Invert Depth: **9.80** (ft.) Flow Characteristics: **Slow**

Infiltration: **None**
